Michaela Zdražilová

FACULTY OF CIVIL
ENGINEERING
CTU IN PRAGUE

INTRODUCTION

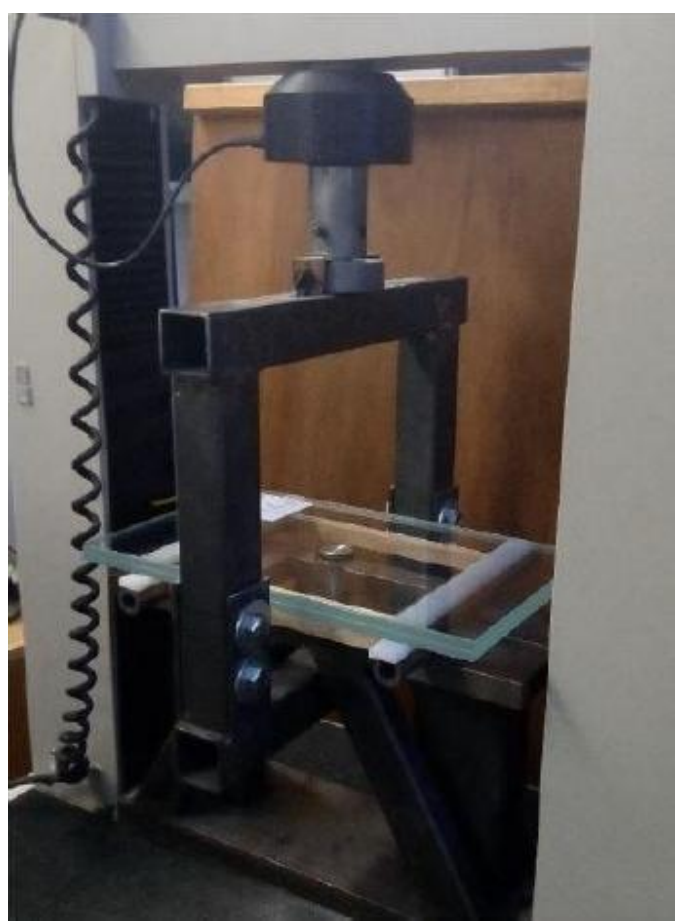
A special frame with detachable bottom part was used to apply the tensile load. The samples were placed on a steel bed with two cylindrical supports and plastic pads.

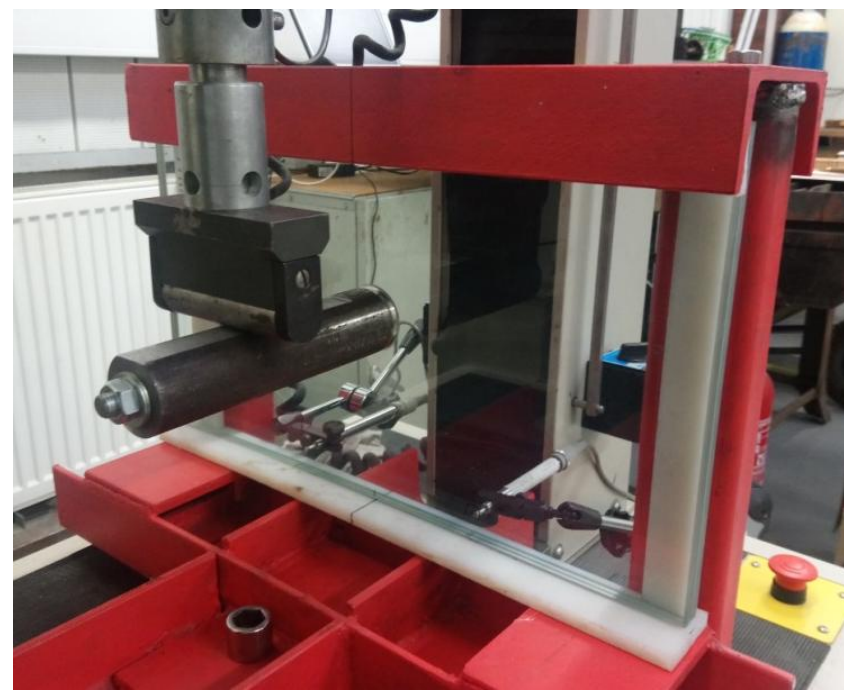
For the eccentric shear load tests, the glass pane was vertically clamped to a steel frame with a detachable upper part. To create the eccentric shear force load, a special steel tool was put on the bolt screwed in the steel element.

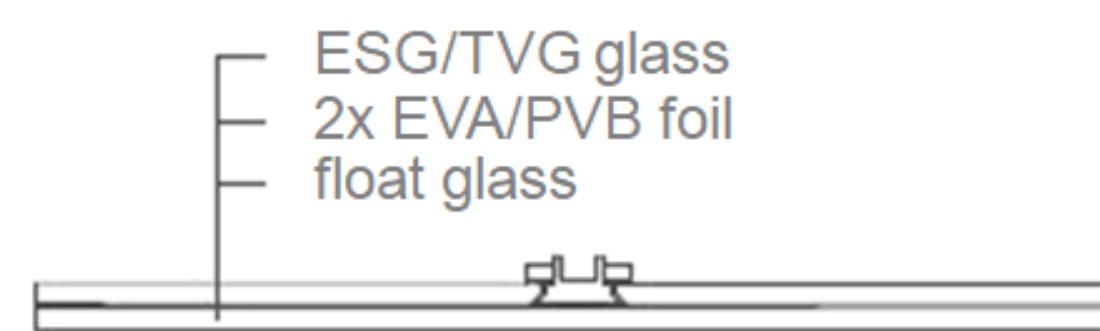
Laminated connection:

- the same manufacturing process as for the standard laminated glass panes;
- combines mechanical and adhesive systems;
- the steel element (bolt) is embedded between two glass panes;
- the adhesive interlayer is represented by two layers of foil.

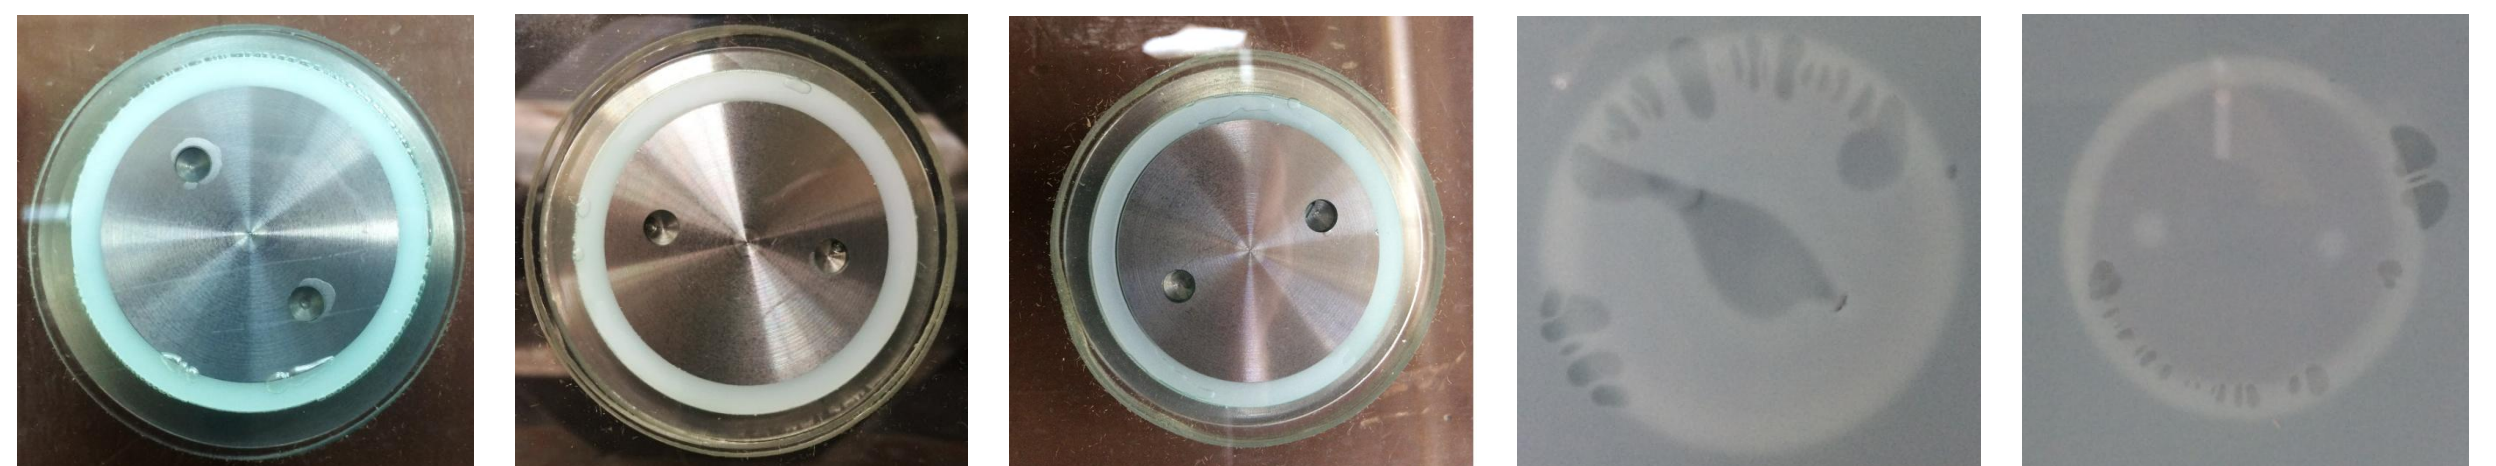
All the samples were checked before the experiment. Defects do not influence the performance of the connection, but they might be unacceptable for the aesthetical reasons.

The samples may suffer from:

- bubbles surrounding the edges of the steel element;
- bigger bubbles in the area of the steel element;
- combination.

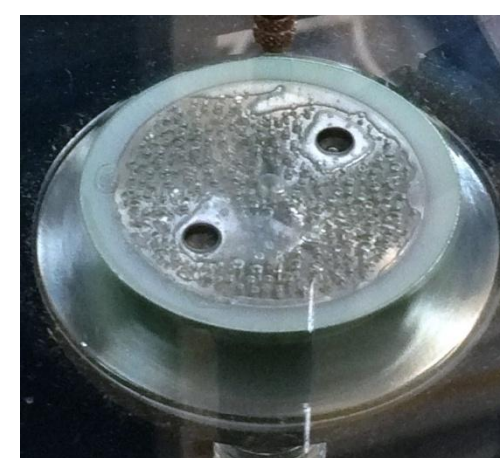
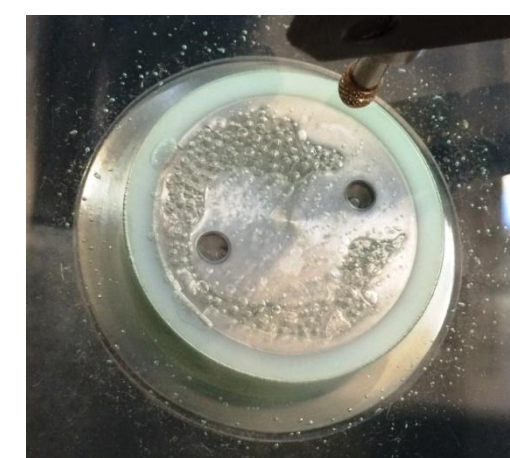
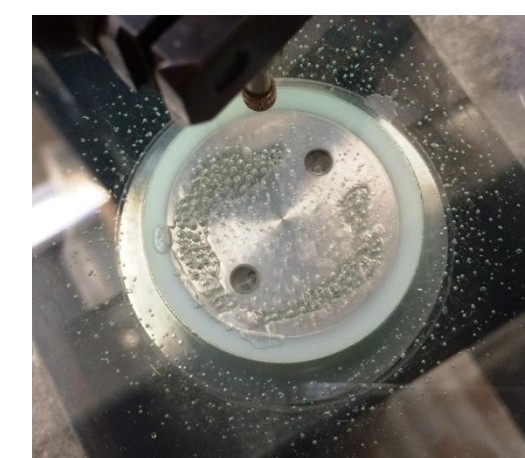
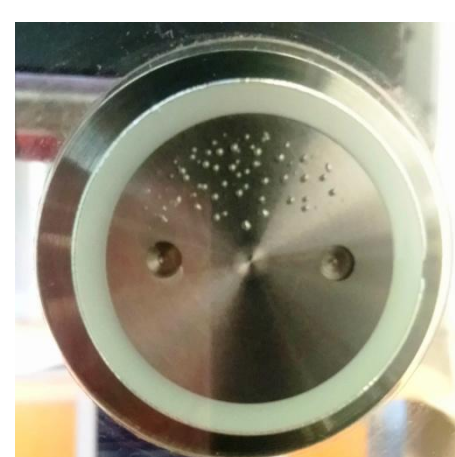
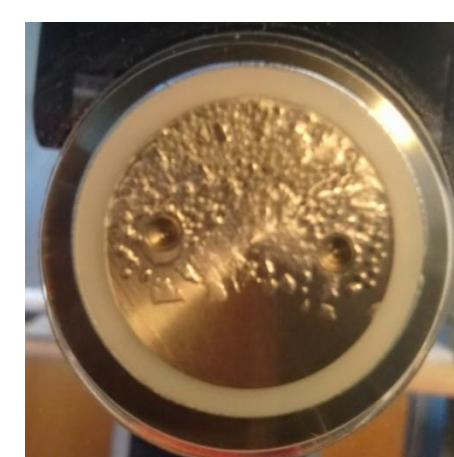
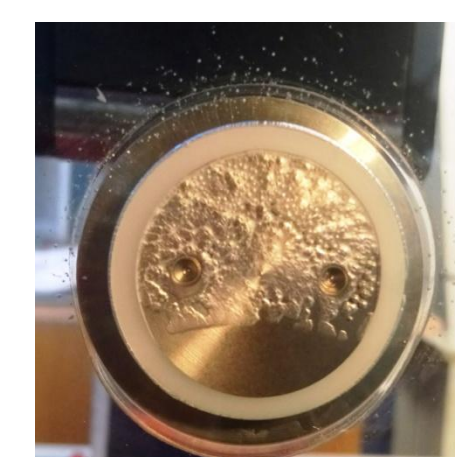
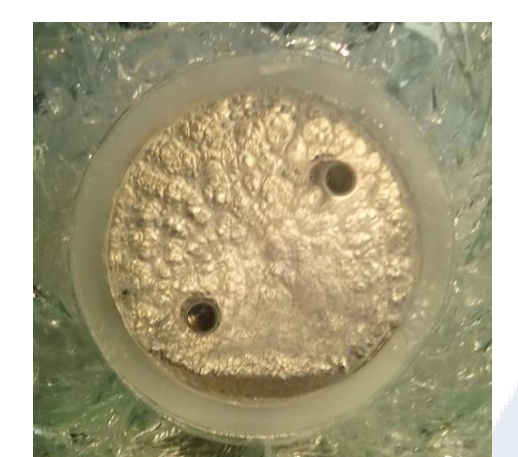
The course of both types of tests was essentially the same:

1. Small bubbles appeared in the area of the connection.
2. Their number was increasing with the increasing load.
3. After reaching a certain point, they started to merge into bigger bubbles.
4. The bubbles eventually covered the whole area of the connection exposed to tension.
5. In some cases, bubbles appeared out of the connection as well.
6. The connection failed due to reaching the tensile resistance limit of the glass pane. No delamination occurred.
